U.S. Army
Coast. Eng. Res.
Ctr.
MP 10-75
(AD-A018 89

Beach Profile Changes : East Coast of Lake Michigan, 1970-72

R.A. Davis, W.G. Fingleton, and P.C. Pritchett

MISCELLANEOUS PAPER NO. 10-75
OCTOBER 1975

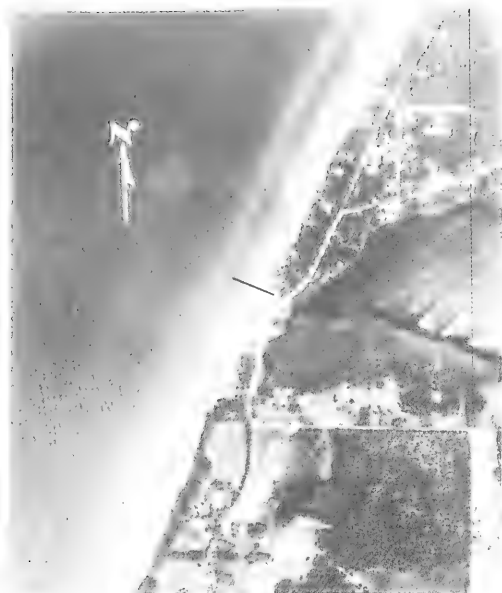
Geomorphology. Site is adjacent to Bar Lake in Manistee County. Shoreline orientation is N.27°E. Beach is bounded by a terrace of beach and dune sands that rises 10 to 20 feet above the lake. Sediment is mostly sand. Scattered fine gravel sometimes is present in the plunge zone only.

Bench Mark Location (3 August 1970)
(SE¼, sec. 24, T.22 N., R.17 W.). On Crescent Beach Road north of Manistee, about 100 feet north of public access beach. Azimuths (from north): 6°10', east margin of larger of two islands; 20°40', corner of house (105°); 41°54', corner of house.

Figure 8. Location and geomorphology of profile site 3.

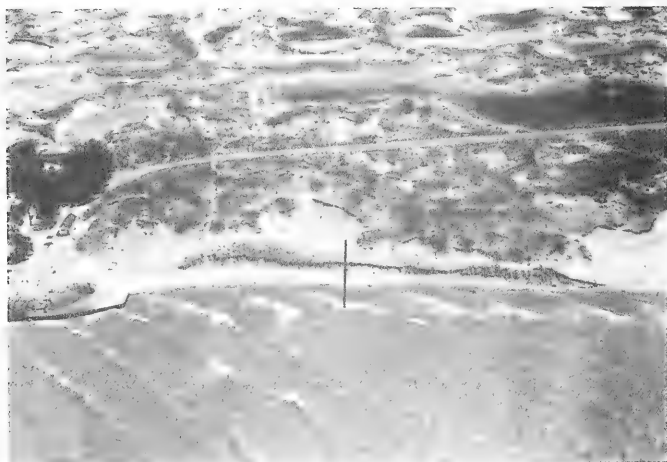
Geomorphology. Beach at Big Sable Point has a shoreline orientation of $N.7^{\circ}E$. This part of the eastern Lake Michigan coast is one of the most extensive dune areas. Dunes extend several miles in either direction from Big Sable Point and a few miles inland at the point. Dunes are covered with grass and small bushes. Virtually no gravel was found, reflecting the proximity to dunes.

Bench Mark Location (3 August 1970)
(SW $\frac{1}{4}$, NW $\frac{1}{4}$, sec. 7, T.19 N., R.18 W.). About 300 yards, south of lighthouse at Big Sable Point, in front of blowout. Azimuths (from north): $7^{\circ}48'$, lighthouse spire; $344^{\circ}50'$, western margin of seawall; $358^{\circ}12'$, U.S. Coast Guard flagpole. Bench mark was moved 15 feet landward 7 April 1972, and 50 feet landward 4 June 1972.

Figure 9. Location and geomorphology of profile site 4.

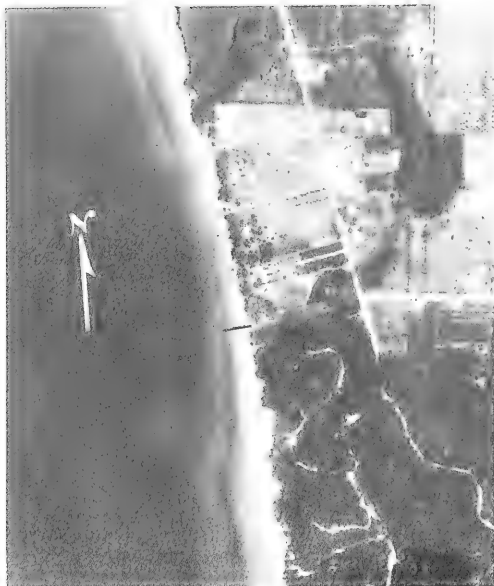
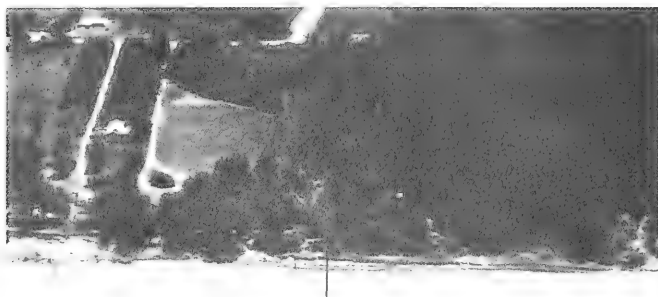
Geomorphology. Beach at Summit Township Park (Mason County) has a shoreline orientation of N.7°W. and is adjacent to bluffs of glacial drift. At times, glacial till was observed cropping out just lakeward of the plunge step. Foreshore comprised of well-sorted and rounded cobbles. Large percentage of the sand in backshore is from a sand terrace where the upper swash of waves has undercut the terrace and vertical slope has failed.

Bench Mark Location (3 August 1970)
(NW¼, sec. 23, T.17 N., R.18 W.). Immediately fronting large, dead maple tree, just south of Summit Park. Azimuths (from north): 83°04', north of maple tree; 201°15', Little Sable Point; 343°19', end of groin; 351°39', large stump west edge.

Figure 10. Location and geomorphology of profile site 5.

Significant beach accretion occurred at site 5 in the spring of 1972; much sand was placed on what is normally a pebble and cobble beach. This

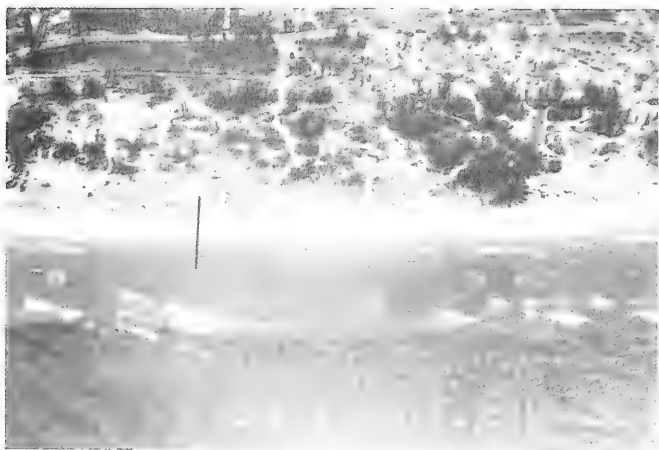
Geomorphology. Shoreline orientation at Little Sable Point is $N.7^{\circ}E.$; beach is just south of large, active dunes near Silver Lake. Immediately adjacent are moderately active small grass-covered dunes. Beach and immediate nearshore composed of sorted, medium sand throughout the year. During the winter this was the only location that did not have a snow cover on the beach at any time, reflecting the significance of wind activity in this general area.

Bench Mark Location (3 August 1970)
($NE\frac{1}{4}$, $SE\frac{1}{4}$, sec. 35, T.15 N., R.19 W.). Public access area about 200 yards north of lighthouse at Little Sable Point. Grassy dune 60 to 65 feet north of path. Azimuths (from north): $164^{\circ}26'$, westernmost of group of three poplar trees ($120'$); $173^{\circ}12'$, lighthouse spire; $357^{\circ}06'$, west side of private beach sign.

Figure 11. Location and geomorphology of profile site 6.

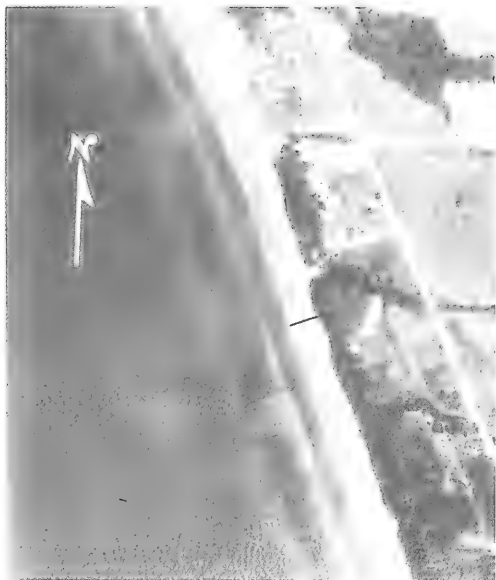
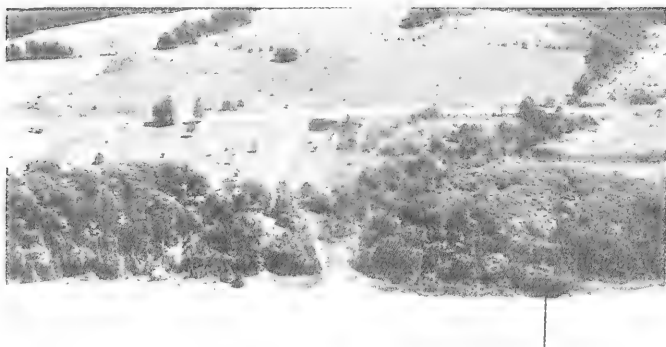
Geomorphology. Shoreline at Claybanks Township Park in Oceana County trends N.18°W. This is one of the most extensive regions of glacial till bluffs along the eastern shore of Lake Michigan. At the base of the bluffs is a narrow terrace of sand which contains a small eolian ridge.

Bench Mark Location (3 August 1970)
(NW¼, sec. 17, T.13 N., R.18 W.). About 100 yards south of southern path to beach at Claybanks Park. On grassy bank in front of steep till bluffs. Azimuths (from north): 162°30', point of land south toward Montague; 325°02', outermost of old piling in surf.

Figure 12. Location and geomorphology of profile site 7.
